Re: State Project: R-2530B
WBS Element: 34446.1.6
NC 24-27 from Bird Road in Albemarle to West of the Pee Dee River

Subject: Preliminary Site Assessment
Parcel #086 – Thaddeus A Furr (Min O Pon)
44022-C Highway 24/27 East
Albemarle, North Carolina
F&R Project #66V-0092

PRELIMINARY SITE ASSESSMENT

**Preliminary Site Assessment Report
Thaddeus A Furr Property (Parcel #086)
Albemarle, Stanly County, North Carolina
F&R Project No. 66V-0092**

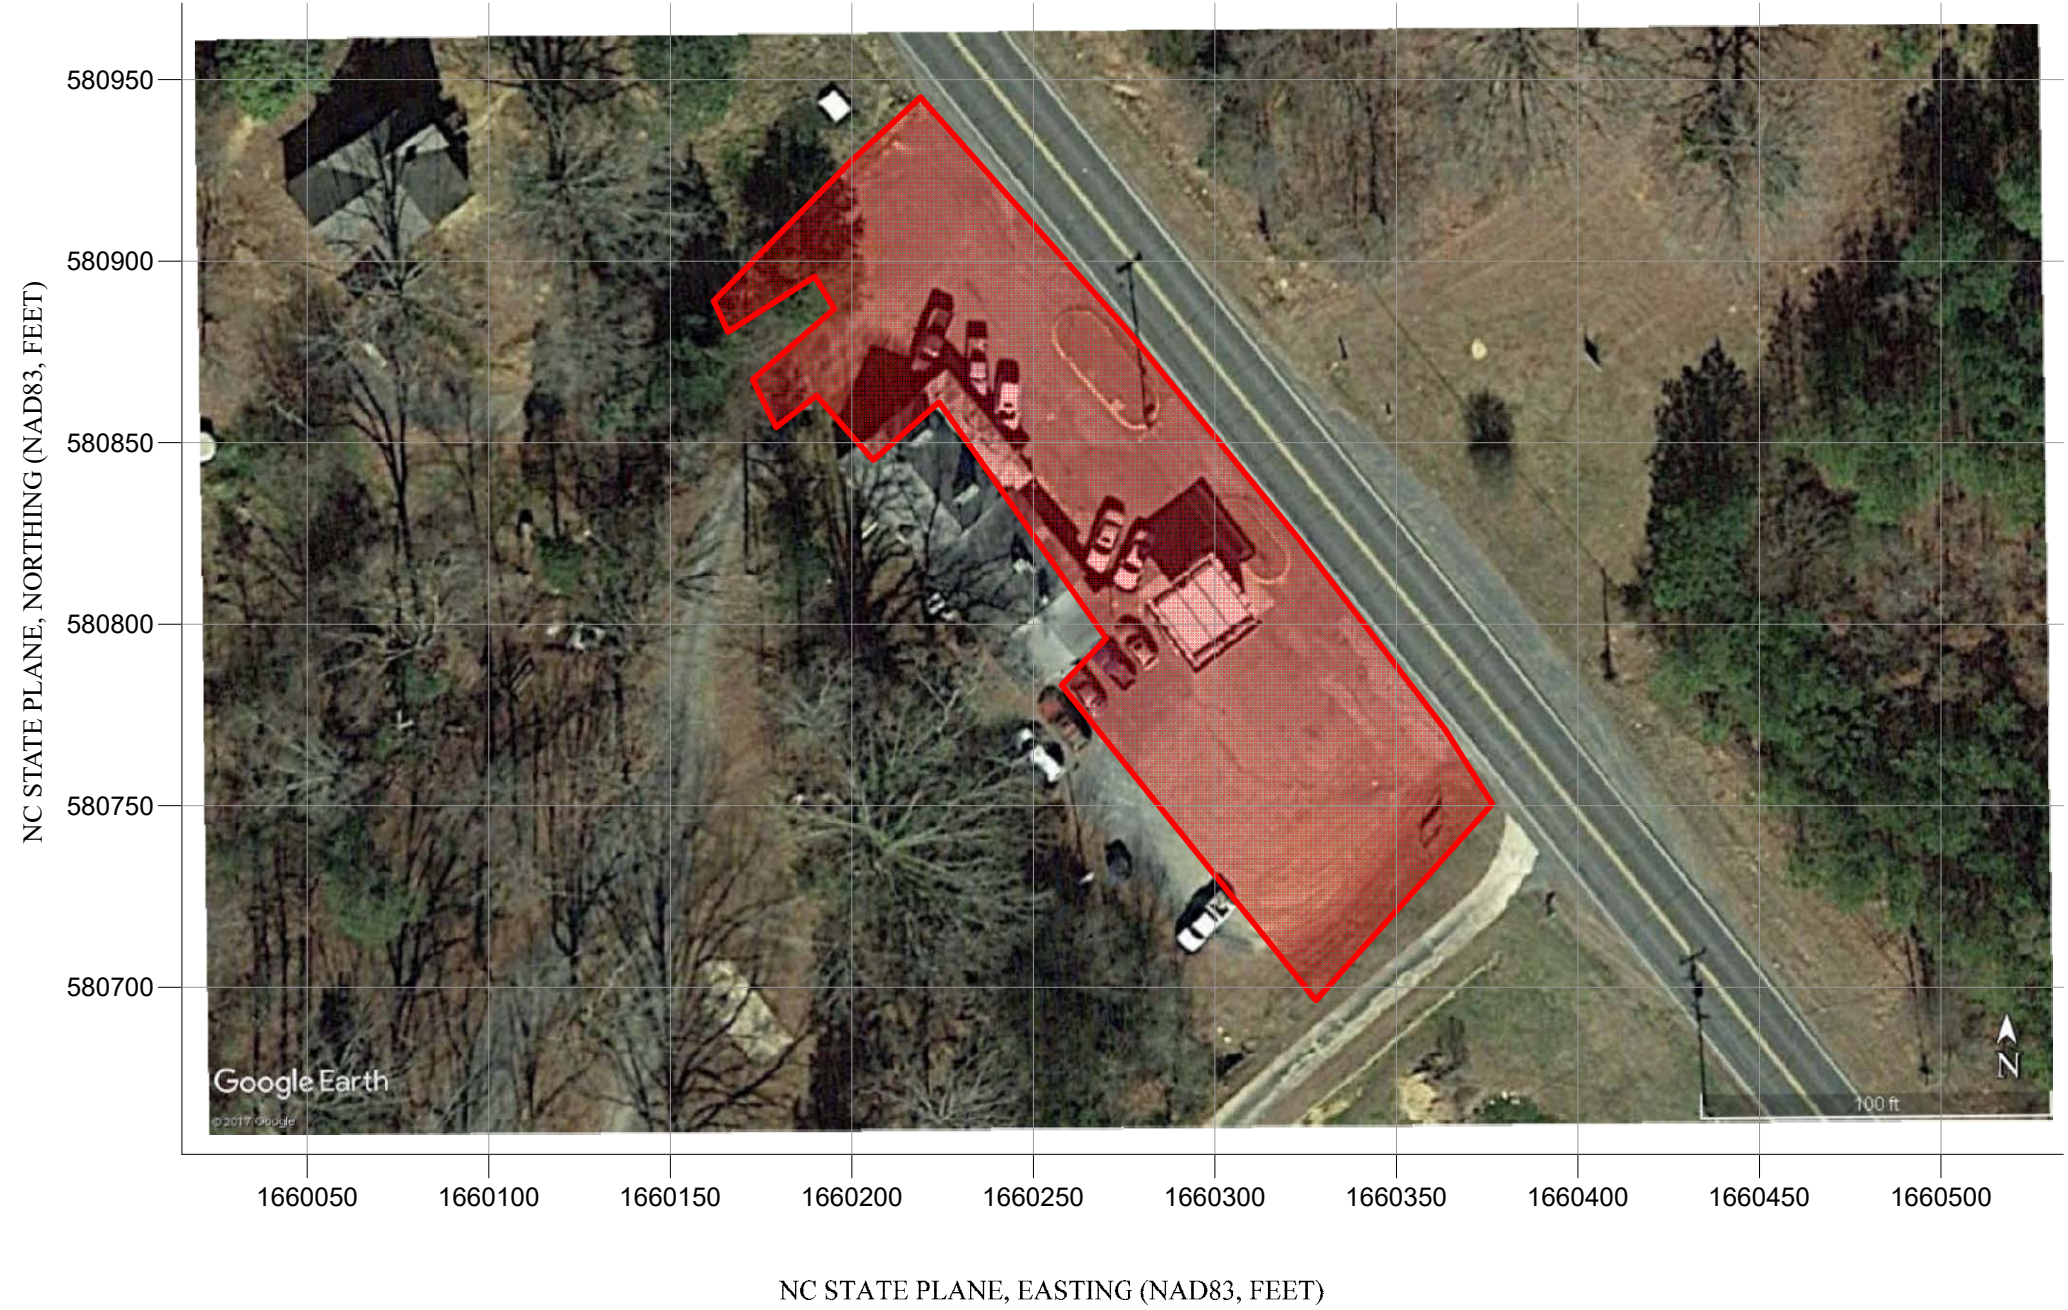
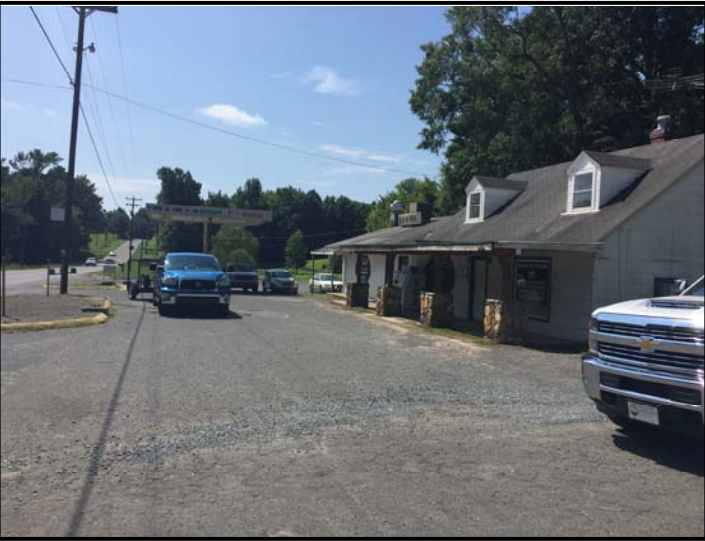
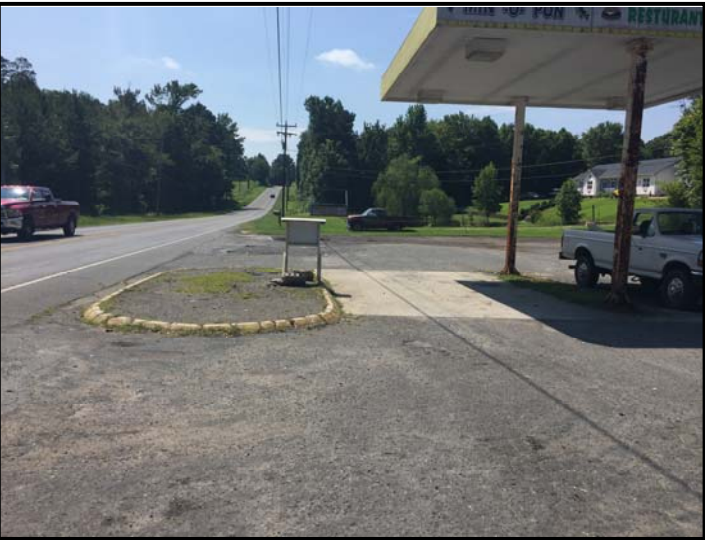
TITLE PARCEL 086 - GEOPHYSICAL SURVEY BOUNDARIES AND SITE PHOTOGRAPHS		
PROJECT PARCEL 086 ALBEMARLE, NORTH CAROLINA NCDOT PROJECT R-2530B		
<div>

APPROXIMATE BOUNDARIES OF GEOPHYSICAL SURVEY AREA

View of Survey Area
(Facing Approximately Southeast)

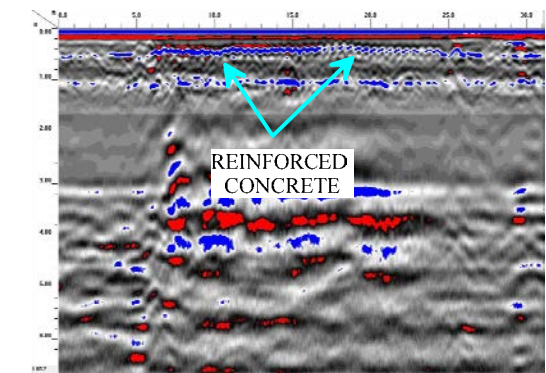
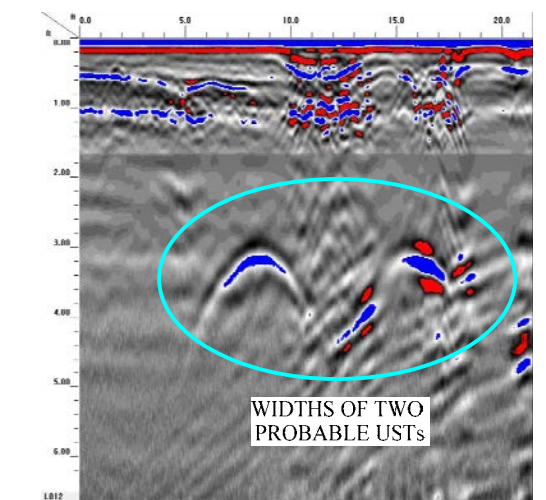
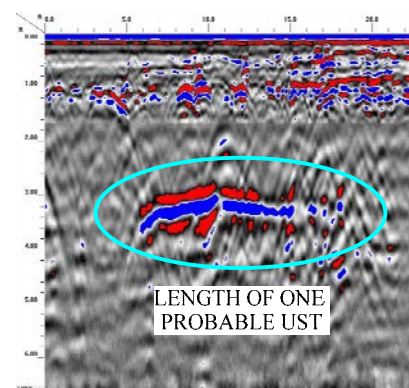
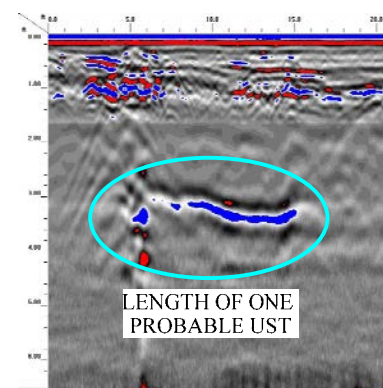
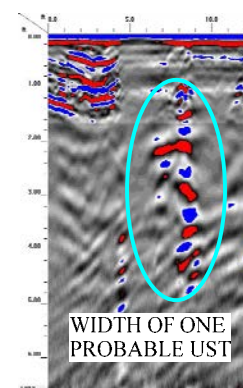
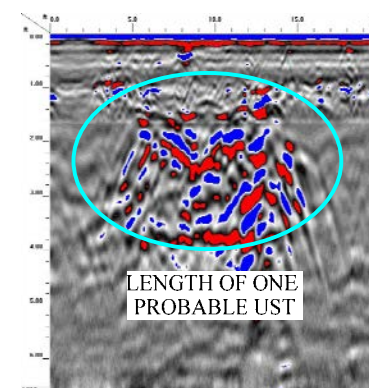
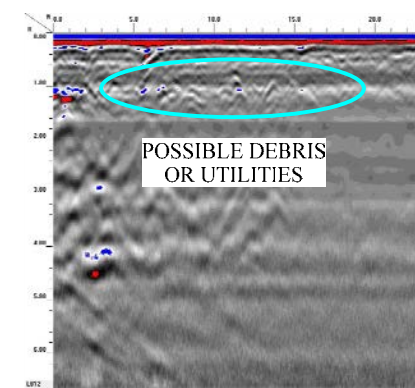
GPR TRANSECT LOCATIONS

Figure 3 presents the locations of the formal GPR transects performed at the property, as well as select transect images. All of the GPR transect images are presented in **Appendix A**. A total of twelve GPR transects were performed at the site. GPR Transects 1-5 were performed across Anomaly 2 on the east side of the building, and verified that this EM feature was the result of metal-reinforced concrete. No evidence of any structures underlying the reinforcement was observed.

GPR Transects 11 and 12 were performed across Anomaly 5, and recorded minor disrupted reflectors and hyperbolic features that suggested possible buried metallic debris or portions of utilities. No evidence of additional USTs was observed at this location.

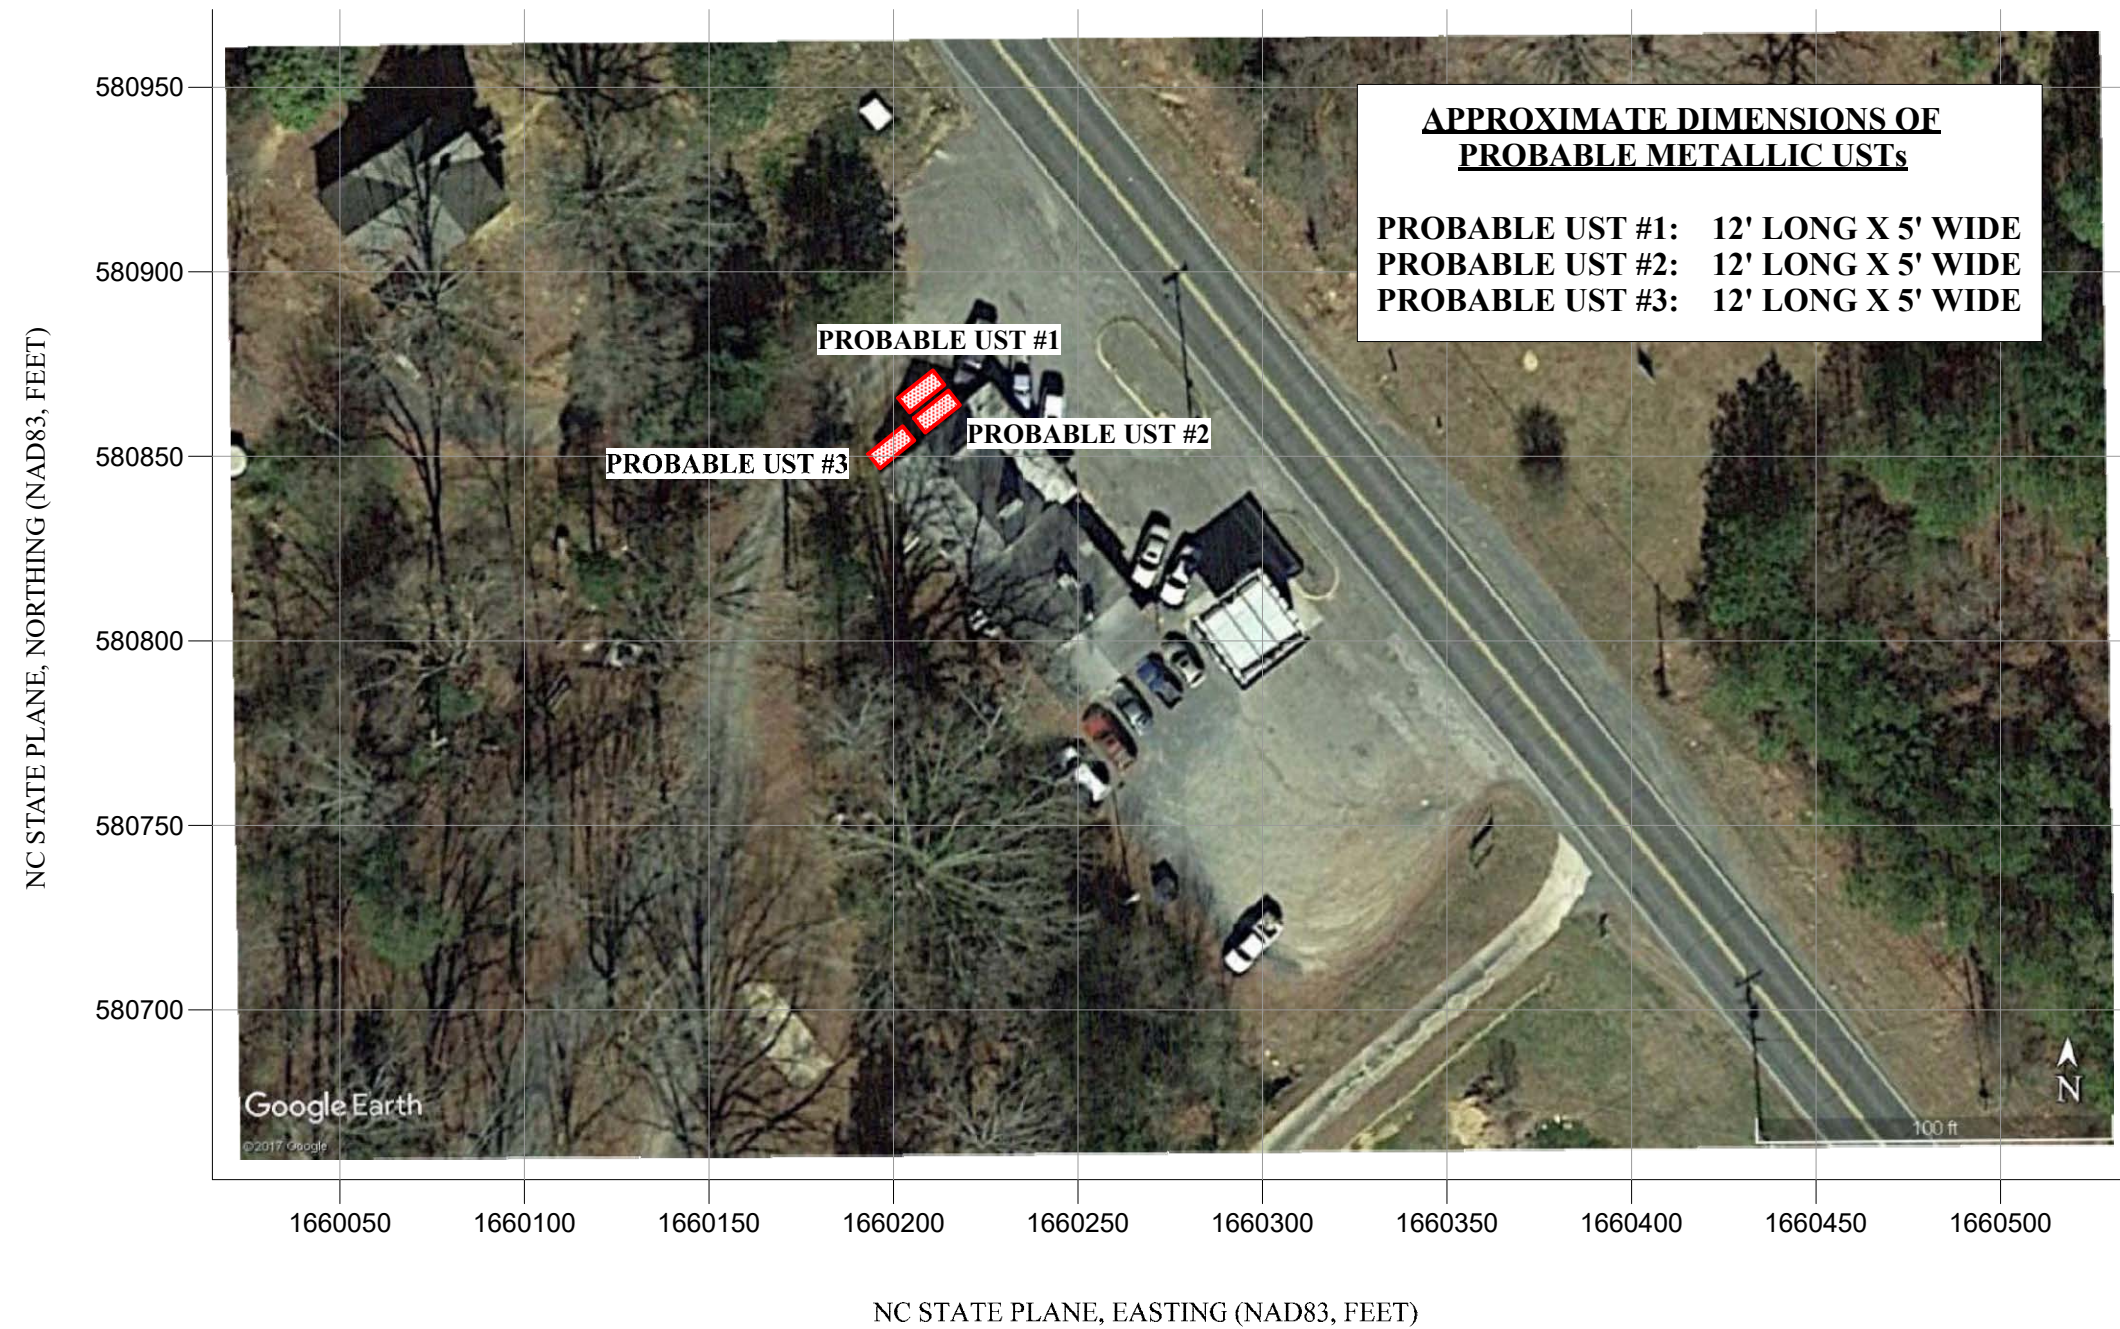
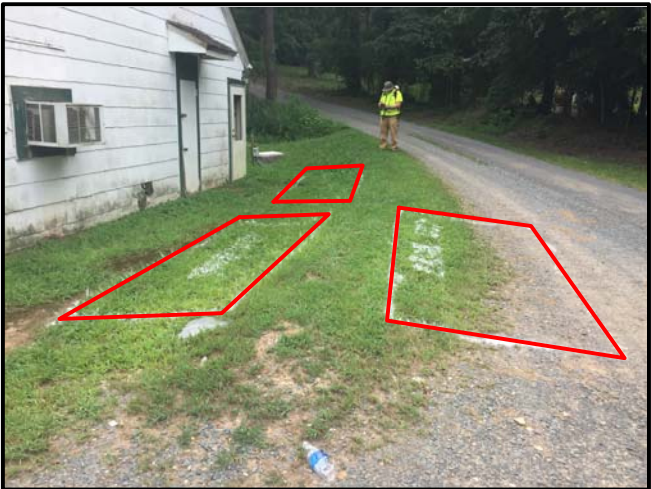
LOCATIONS OF PROBABLE METALLIC USTs

- The three probable metallic USTs were all approximately 12 feet long and 5 feet wide at depths of approximately 2-3 feet below the ground surface.
- It should be noted that the westernmost probable UST was outside of the EM geophysical survey area, but was identified during the GPR survey across this location. This probable UST is observed to lie directly on the NCDOT easement, with the majority or all of the actual tank located outside of the easement.

View of Three Probable USTs
Facing Approximately West

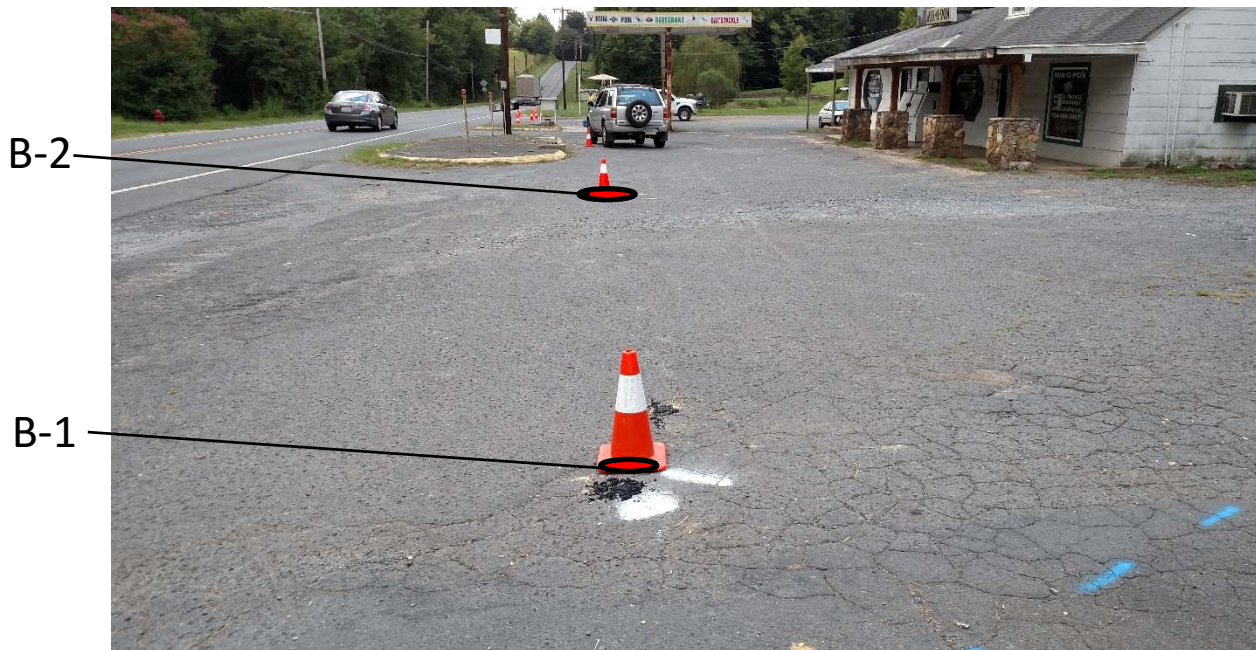
Photo #1: Boring locations B-1 and B-2, facing southeast.

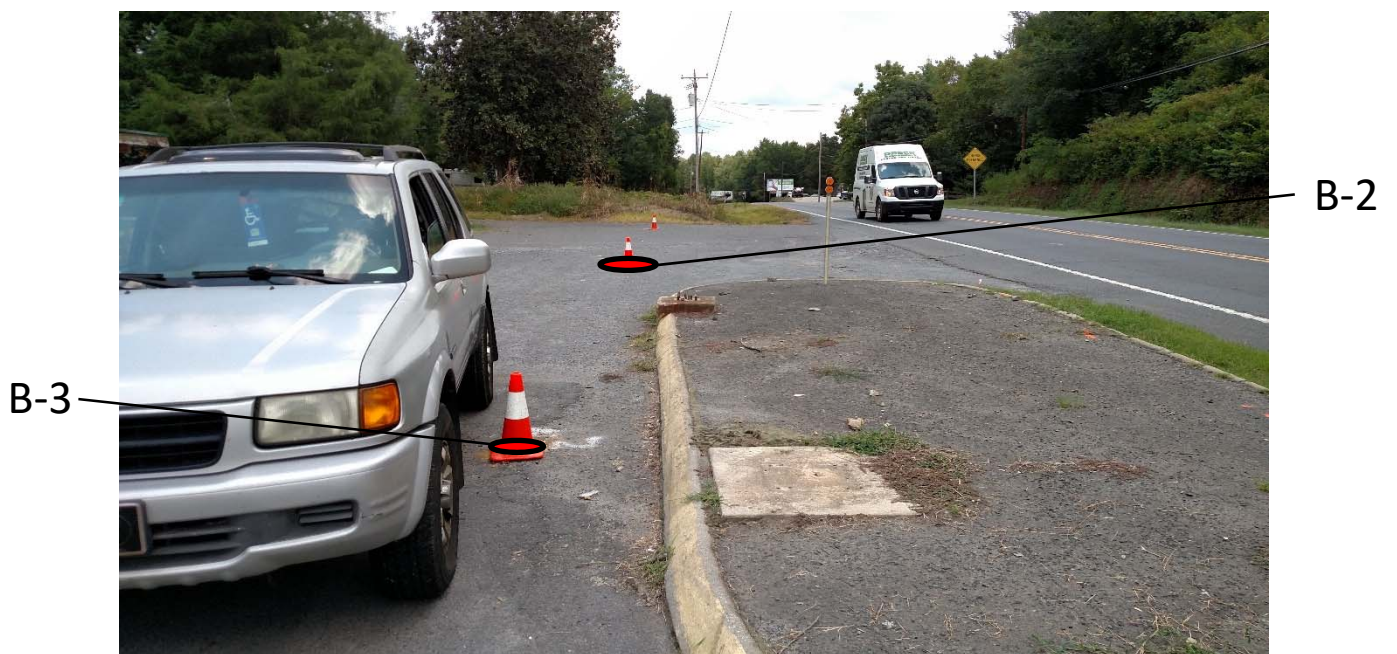
Photo #2: Boring locations B-2 and B-3, facing northwest.

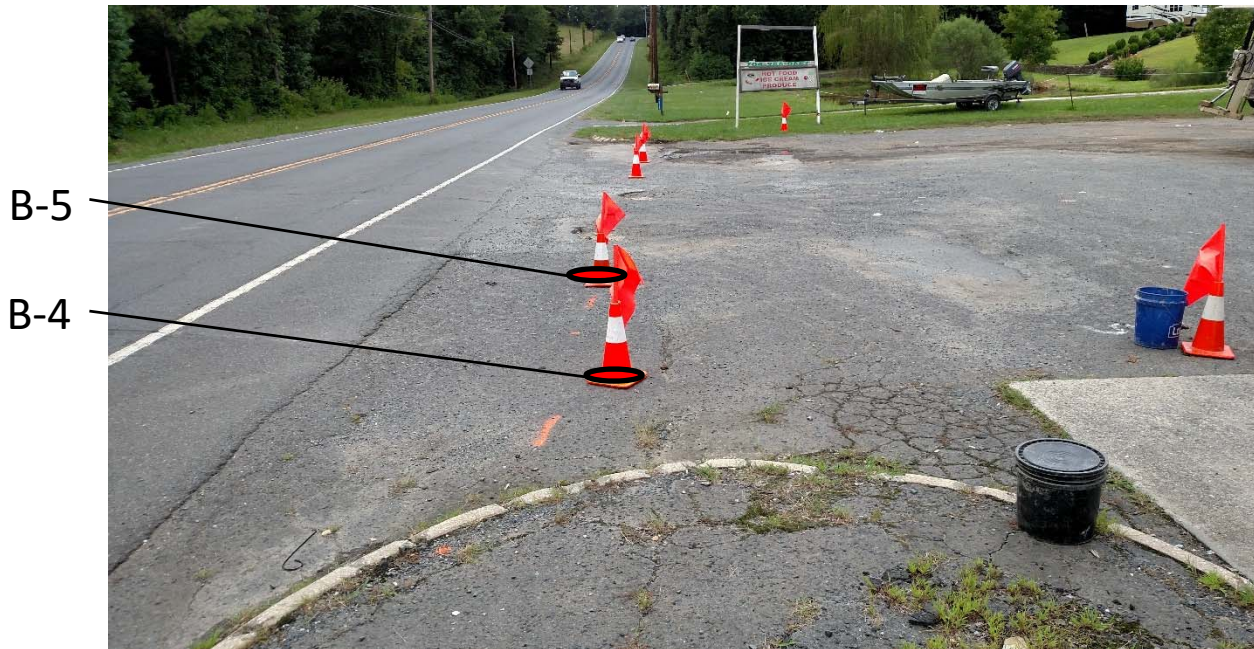
Photo #3: Boring locations B-4 and B-5, facing southeast.

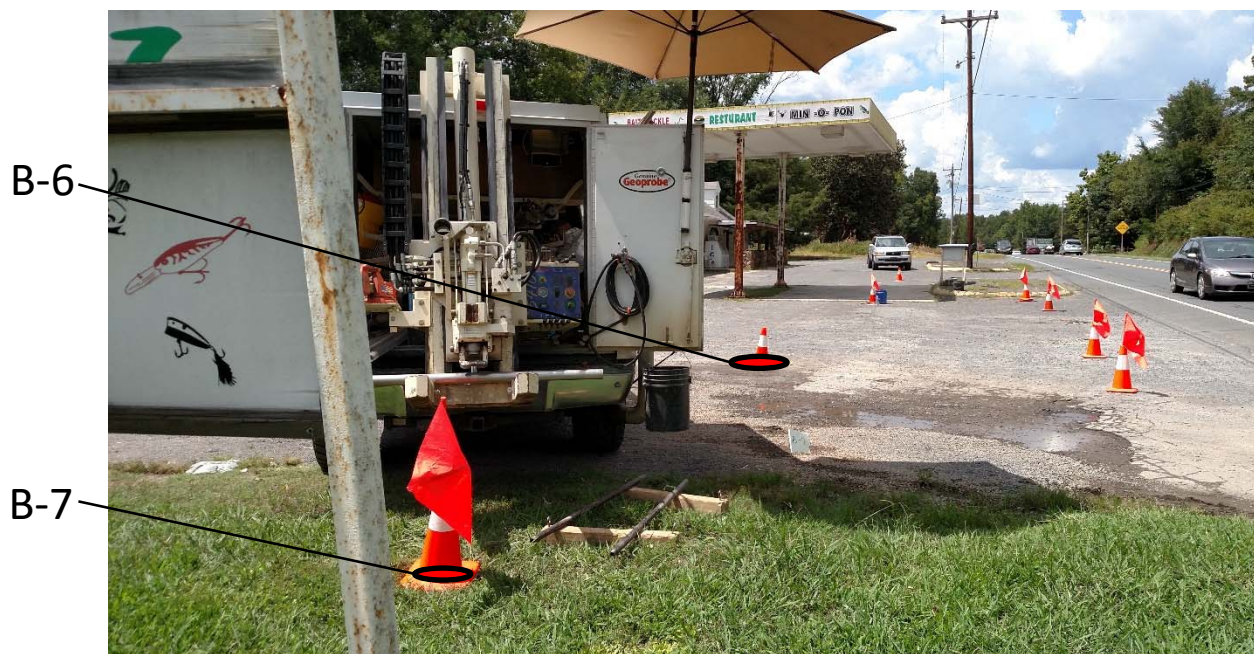
Photo #4: Boring locations B-6 and B-7, facing northwest.

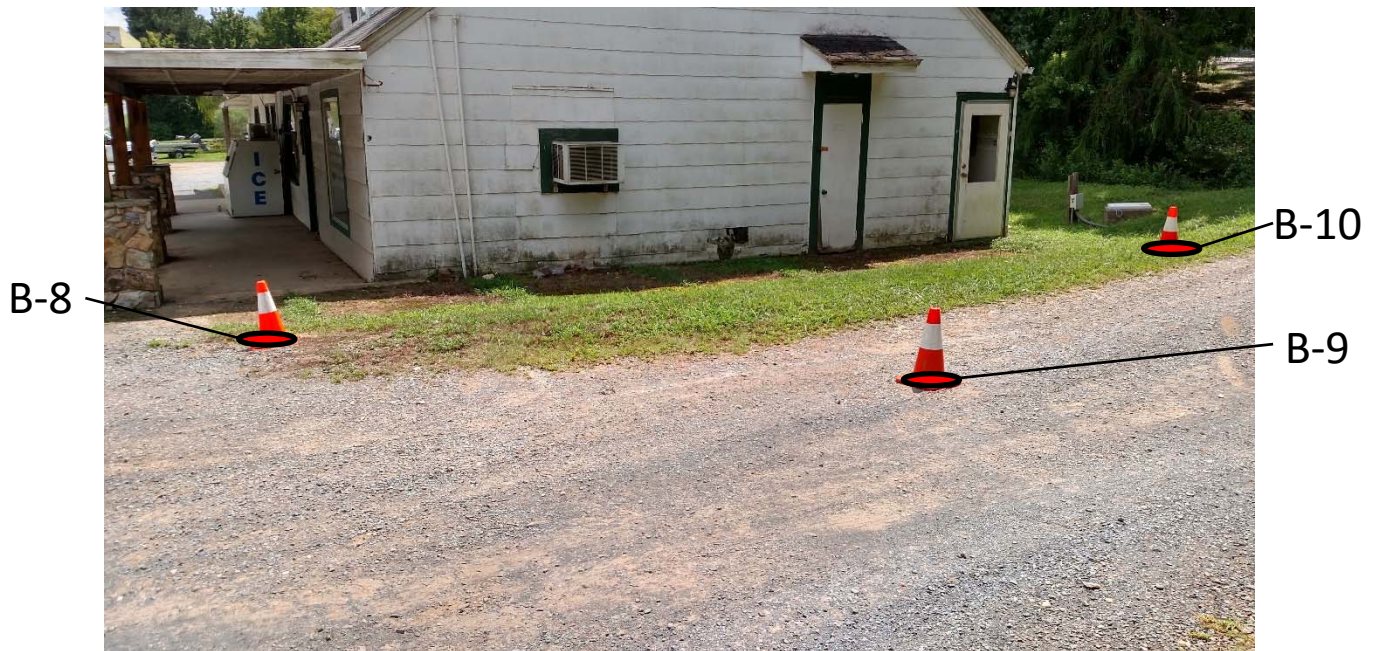
Photo #5: Boring locations B-8, B-9, and B-10, facing south.

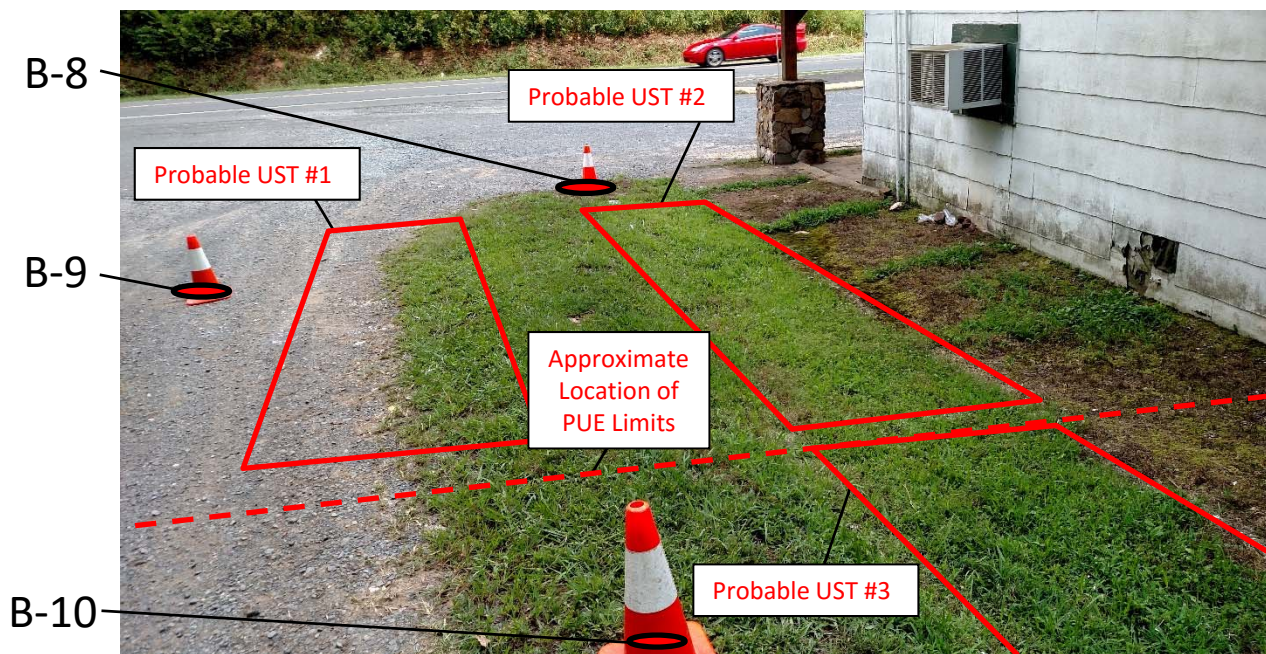
Photo #6: Boring locations B-8, B-9, B-10, and two probable USTs located just northwest of the gas station/restaurant building, facing east.
